INDOOR AIR QUALITY REASSESSMENT

**Allen Avenue School
290 Allen Avenue
North Attleborough, Massachusetts**

Prepared by:
Massachusetts Department of Public Health
Center for Environmental Health
Emergency Response/Indoor Air Quality Program
August 2005

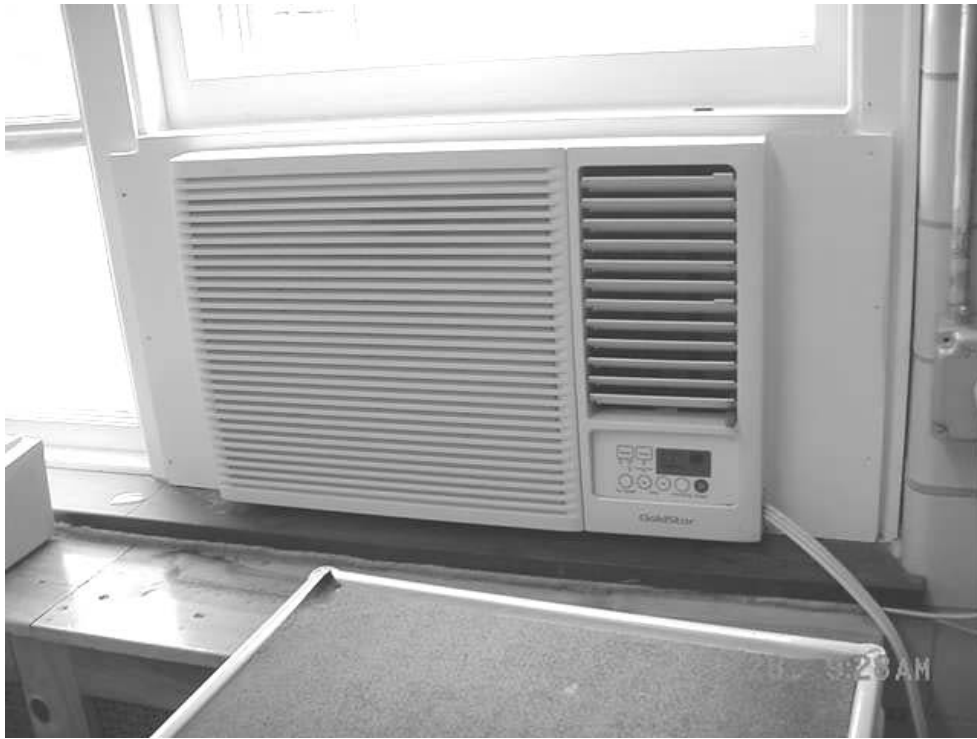
Picture 1

Several areas (e.g., the computer room, main office) are not equipped with mechanical ventilation. Instead, fresh air is provided by open windows. However, window-mounted air conditioners (ACs) have been installed in these areas (Picture 1). To provide a mechanical means to introduce outside air, the ACs can be set to the “fan only” or “exhaust open” setting (Picture 2). When operating in either mode, air conditioning units can provide air circulation by delivering outside air without cooling (i.e., outside air temperature).

Window-Mounted Air Conditioner, Note Keypad Control in Corner has “Fan Only” Function

4. Operate air conditioners in the “fan only” or “exhaust open” setting to introduce outside air.
5. Operate all ventilation systems that are operable throughout the building (e.g., gym/cafeteria, classrooms) continuously during periods of school occupancy independent of thermostat control.

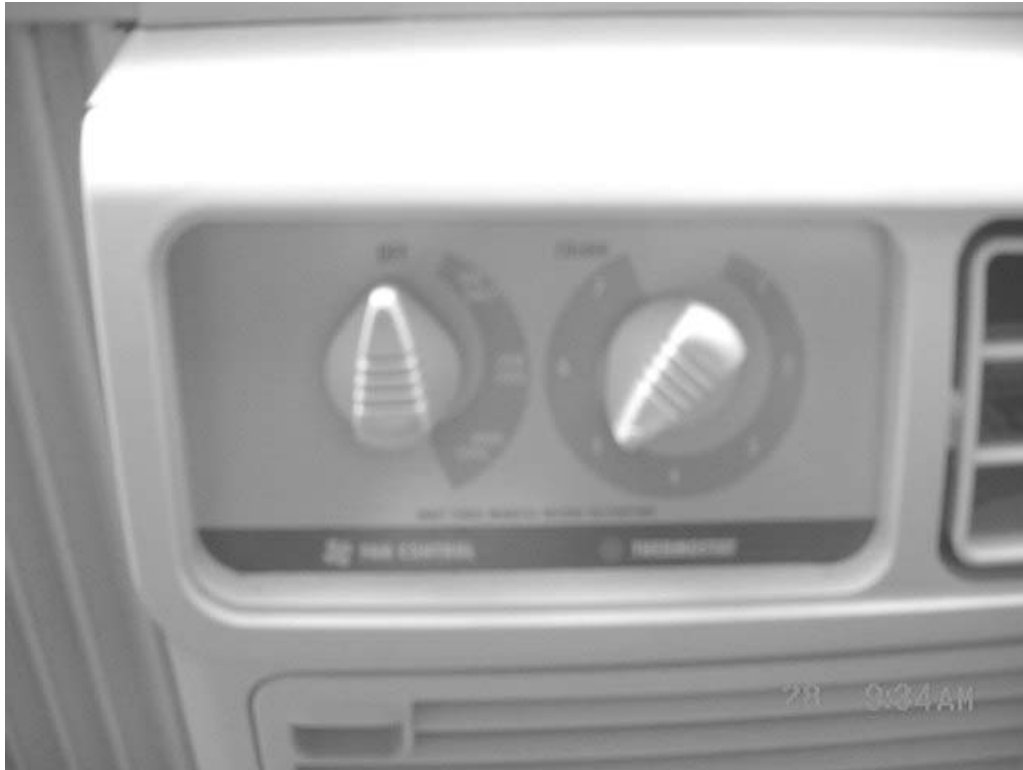
Picture 2

Close-Up of Window-Mounted Air Conditioner Control Knobs
Note the Knob on the Left has a “Fan Only” Function
